2002 IRP Historical Consulting Services: Peyton Slough Shed, DPR 523 form

State of California – The Resources Agency
DEPARTMENT OF PARKS AND RECREATION
PRIMARY RECORD

*Resource Name or # (Assigned by recorder) Peyton Slough Shed

BUILDING, STRUCTURE, AND OBJECT RECORD

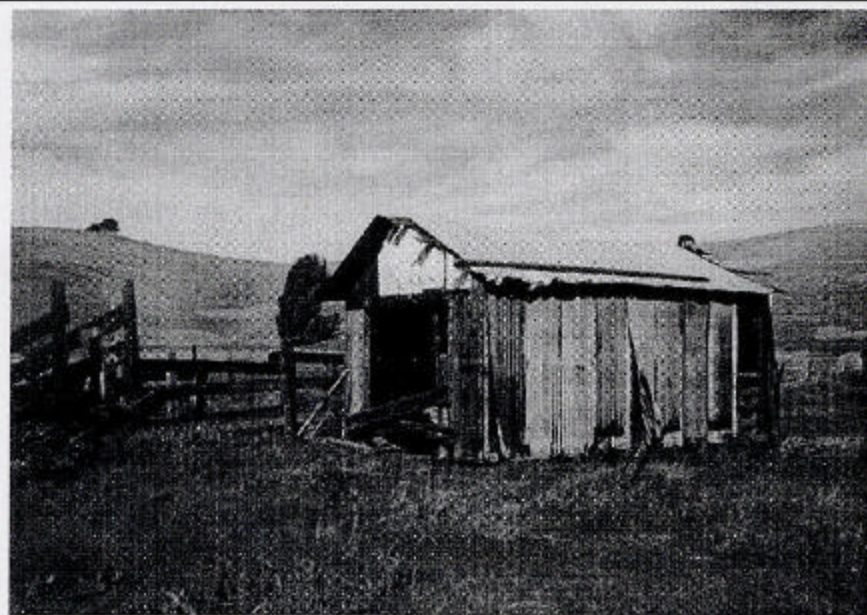
The shed sits on the northern side of both the former Southern Pacific Railroad tracks and the parallel Waterfront Road, and to the east of Peyton Slough. The area around the shed is open marshland encircled by various industrial complexes. The shed is a small rectangular building of wood frame construction. It is a simple front gable building sheathed with corrugated metal panels at the roof and walls. In several places the metal panels have deteriorated substantially, or as is the case at the southeast corner, the metal panel is missing altogether. The original opening is at the west gable end and has no door. There are no openings on the other elevations. A timber post and plank corral and a loading chute are located to the north and northwest of the shed. This fencing includes many types of replacement and repair fencing such as bailing wire, chain link, and chicken wire.

P5b. Description of Photo: (View, date, accession #) Photo #1, January 9, 2002, camera facing north

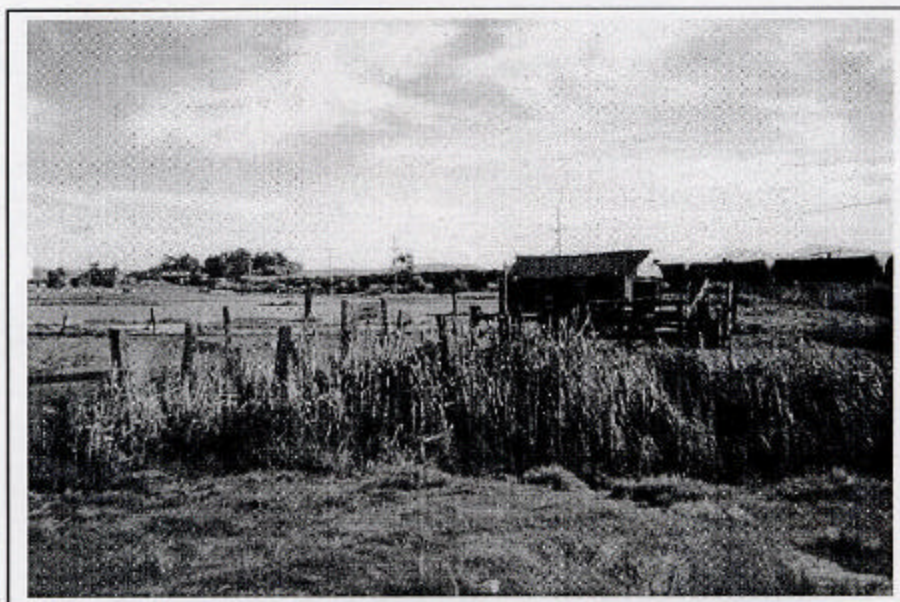
Photograph 2. Shed and corral, camera facing southeast.
